Corrosion Coupon Report

Customer : Midwestern Meat Processing Plant
Address: Midwestern USA

Report Date: 7/18/01 to 1/24/02
Coupon Location: Evaporative Condenser

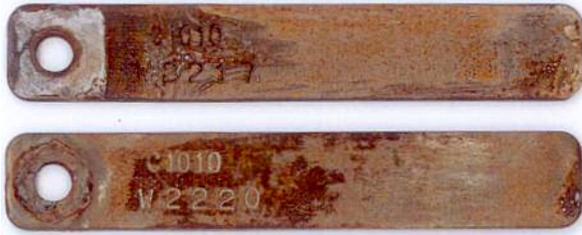
Coupon Photos:

The Coupon surfaces was free from deposits and from pitting. Both coupons indicate corrosion rates well below 1 mpy. This indicates excellent overall corrosion protection. The coupon which had been in the system for 6 month showed somewhat lower corrosion overall rates than the more recent coupon. There was some “copper-like” staining on the surface of coupon, but this did not appear to be related to system corrosion.

The corrosion coupon results indicate very low general corrosion rates during this time period. Corrosion rates below 1 mpy are generally considered very good as long as there in no significant pitting corrosion.

The low corrosion rates indicates good plant control of water chemistry in this system during this period.

The current treatment program is the new corrosion inhibitor program. We are using ortho phosphate and molybdate as corrosion inhibitors. The Ryznar index is maintained at a slightly corrosive condition to maintain scale inhibition. Maintaining low mild steel corrosion rates in this system is critical because the condenser tubing is previously galvanized tubing with the galvanized layer stripped off. High mild steel corrosion rates and or pitting corrosion will result in premature tube failure in the condenser.
