# WATER TREATMENT TECHNOLOGY FOR INDUSTRIAL, COMMERCIAL & ENVIRONMENTAL APPLICATIONS

AUGUST 2014 - WATER TREATMENT NEWSLETTER

## Not all Membrane Autopsies are Created Equal

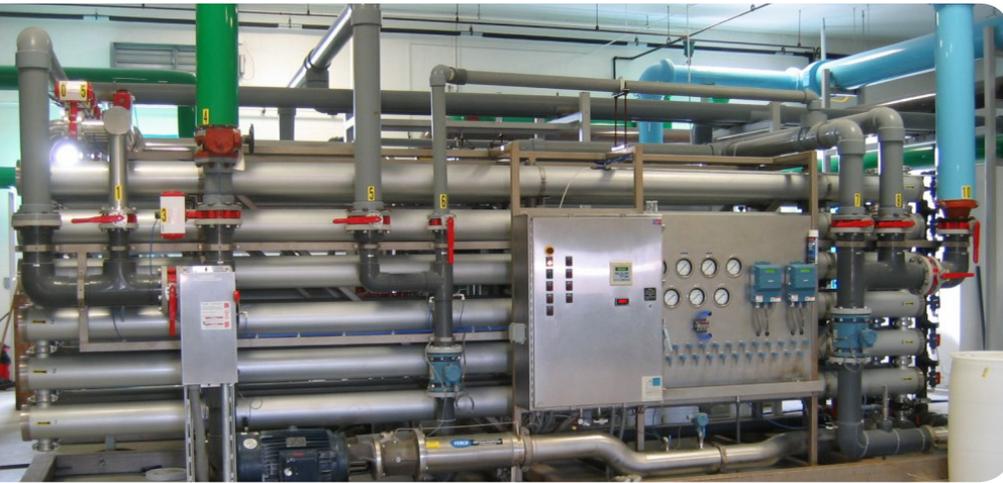
Coordination of efforts with the Avista's analysts and the plant's chief chemist yielded important information. Additional water samples were obtained for some specialized tests. The Avista analysts used their FTIR (Fourier Transformed Infrared Analyses) to identify organic peaks found in the feedwater and on the surface of the membrane. Those peaks were identified as non-ionic surfactant compound(s) which was(were) in effect "poisoning" the membrane surface. (Pages 18-20 of the report)

Normal autopsy procedures did not identify the problem with the membrane. The Scanning Electron Microscopy (SEM) enhanced with Chromatic Elemental Imaging (CEI) showed only minimal fouling and no explanation for the loss of permeate flux. (Page 22 of the report) ➤

This information was the key to understanding the loss of permeate flow. It also shows the importance of a thorough autopsy performed by experienced, knowledgeable technicians who have the tools to do both standard and non standard autopsy work. Our experience also showed the importance of coordinating laboratory autopsy results with the personnel at the plant who have insight as to their RO system operation.
